The Locomotive

THE HARTFORD STEAM BOILER
INSPECTION AND INSURANCE CO.

VOL. XXXVIII

HARTFORD, CONN.
1930-1931

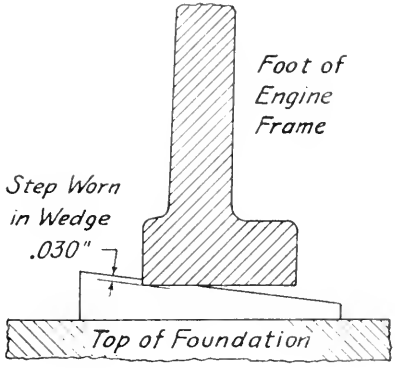
Figure 2.

further around the frame neck. Leaving the leveling wedges under the frame after erection of the engine is no safeguard against the baneful effects of oil softening of the grouting since, as already mentioned, the small contact area of the wedge with the frame wears away rapidly as

shown in Fig. 2. In a recent case where the frame neck had cracked the wedge which was pulled from under the frame at "A" had a step worn in it of .030". This, of course, was the amount that the engine frame had sagged at that point. The vertical movement of the frame must have been a considerable proportion of this.

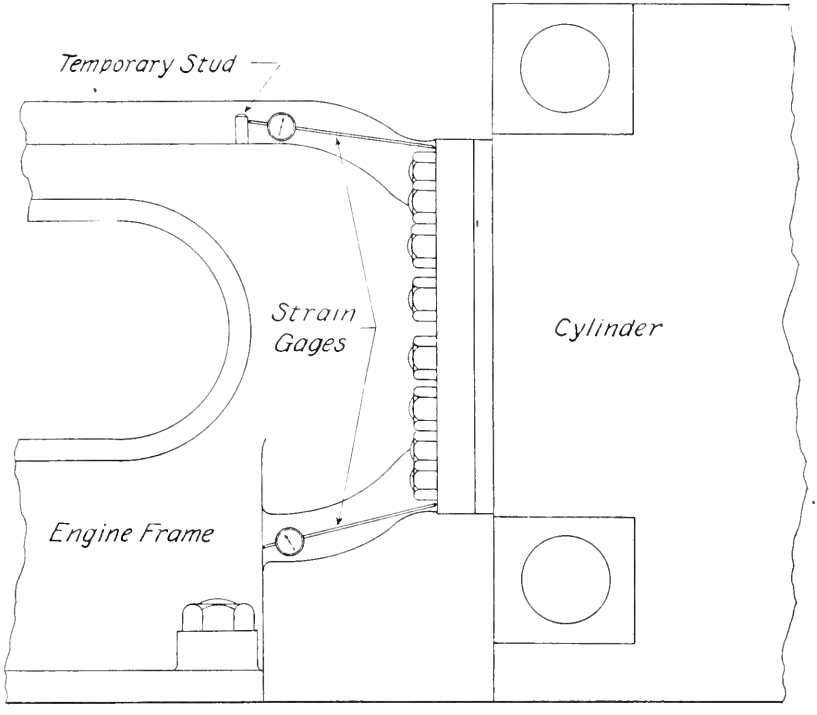
Fig. 3. Showing Application of Strain Gage.

bending stress in the frame neck due to sagging of the frame can be detected. This is by applying to the frame neck a simple strain gage such as is used by this Company's inspectors. The application of this strain gage is shown in Fig. 3. So long as the readings of the dial micrometer are reasonably alike at the top and the bottom of the frame while the engine is running under load there will be no trouble from cracking of the frame neck, as this indicates that there is no bending action at that point.

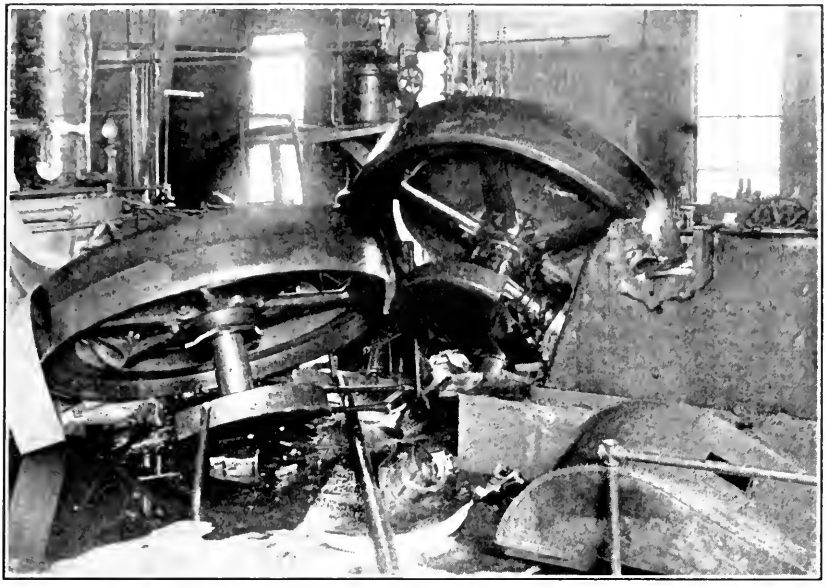
It doesn't necessarily require overspeeding and a flywheel explosion to tear an engine to pieces. This recent oil engine wreck occurred as a result of fatigue failure of the crank-shaft. Noticing that the engine was running irregularly and making a lot of noise, the engineer decided to shut it down. He had already cut off the fuel supply when the shaft parted.

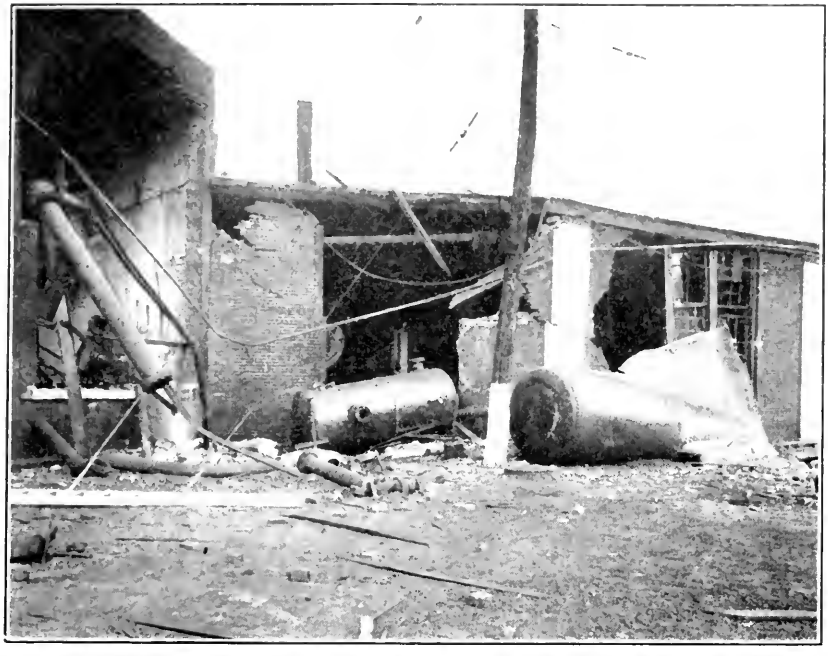
An investigation after the accident revealed that one of the steel strips in the compressor's feather-type discharge valve had broken in two and curled up. From all appearances it had been subjected to great heat, for whereas such strips are made of tempered steel, this one could easily be twisted and bent by hand. It has been demonstrated on many occasions that leaky discharge valves will cause abnormal

heating of the discharge air. The assumption is that this heat is developed by recompression of hot air that leaks back from the line through the valve after the piston has completed its compression stroke and is traveling in the opposite direction. When the temperature reaches

the ignition point of the particular mixture of oil vapor and air in the line at the time, an explosion results.

The extent to which pressure may reduce the temperature necessary to ignite certain mixtures of air and vapor from the various sorts of lubricating oil would seem to be an appropriate subject of laboratory research. In any event the danger of explosions of this nature makes it advisable for every engineer having compressors under his charge to choose lubricating oil with care and to see that oil is not used in excess quantities. The temperature of the discharge air should be watched closely, for the combination of oil vapor, air, and high temperature seems to be a treacherous one.

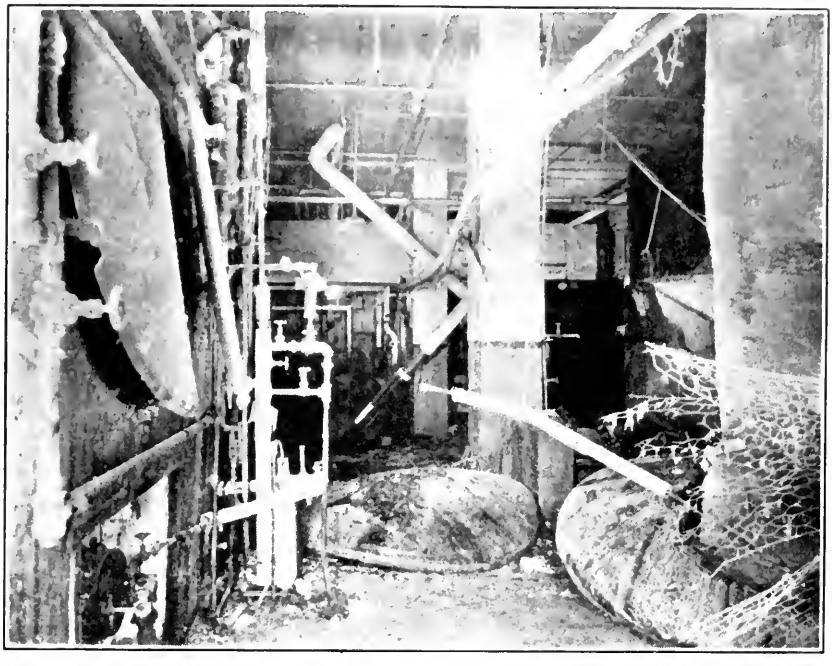
Figure 2.

A majority of hydro-pneumatic systems are motor-driven units with some sort of an electrical relay which starts and stops the motor automatically at certain pressure limits. Figure 2 shows the damage caused recently by the explosion of a tank in such a system at a hotel. This system had no safety valve, the relay being depended on to prevent over-pressure by shutting down the pump. However, the relay failed to work and the resultant property damage was close to $5,000. Figure 1 is a view of another such tank that failed by blowing out the head and tearing along the longitudinal seam.

Automatic controls for the pump should not be depended on as the only protection against over-pressure. In all cases they should be augmented by a relief valve installed either on the tank or on a pipe freely communicating to the tank. Where the relief valve is on some

part of the piping system, it is important to see that no check valve or stop valve is installed between it and the tank.

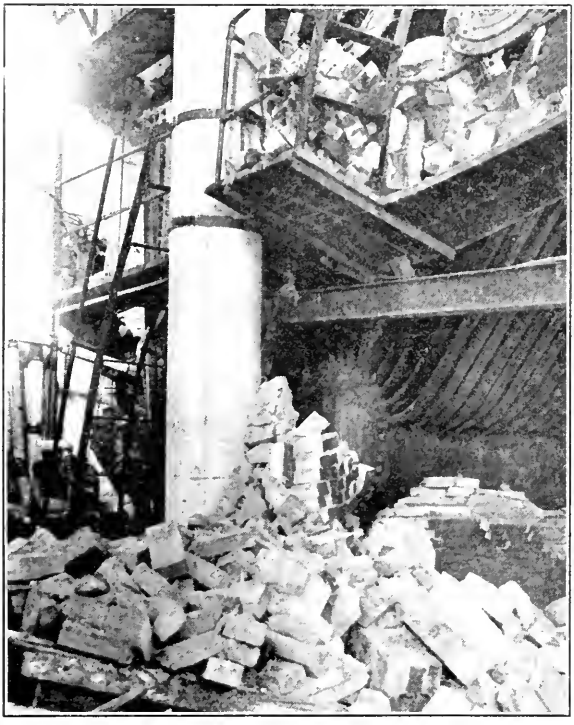
THE engineer of a large modern laundry in Hollywood, California, was severely injured on October 28 when a fuel explosion in the furnace of a gas-fired power boiler wrecked the setting and blew out a brick building wall. He was not only burned about the head and hands by the sheet of flame that swept through the boiler room, but was hurled twenty feet through a window.

The steel columns supporting the boiler and the 18″ steel girders between these columns were so badly bent and twisted that an entire new supporting structure had to be installed. Deflection of the support caused the boiler to drop about three inches, breaking the blow-off pipe, the safety valve "Y", and several smaller pipe connections. A companion boiler also was badly damaged, as the explosion ripped open the breeching and carried away the safety valve. It took thirty-six hours to place the spare boiler in operating condition. Figure 1 shows some of the property damage, which was estimated at $6,000.

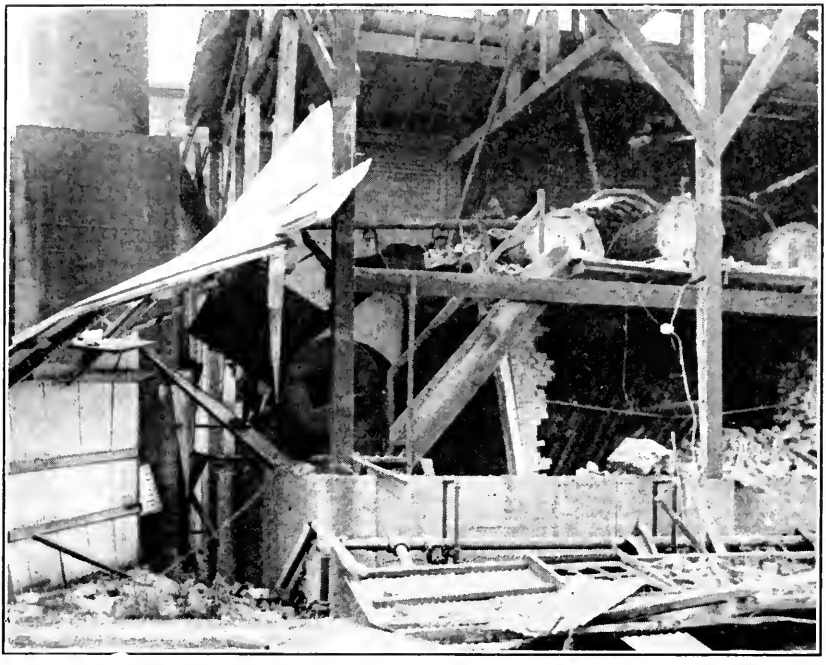
Figure 2

July when the engineer of a paper products plant in Los Angeles lost his life. As in the case just described, the breeching was destroyed and the brickwork of the setting knocked down. Caught under the brick wall as it fell, the engineer was crushed. As is indicated by the illustration shown in Figure 2, the property damage was considerable. An estimate placed the plant's financial loss at $10,000.

It was thought that perhaps the accident was caused by the engineer permitting the gas pilot to flow too long before igniting it, but as the victim was alone in the boiler room at the time this supposition could not be checked. It seems more probable, however, that there may have been a leak in the gas or oil lines that resulted in the furnace filling up with combustible vapor, as in the case previously described.

bustion chamber. Tips and nozzles of oil burners should be looked over to see that they are clean and securely connected to the oil lines, and with installations where there is an arrangement for preheating the oil, this temperature should be right before the burner is lighted.

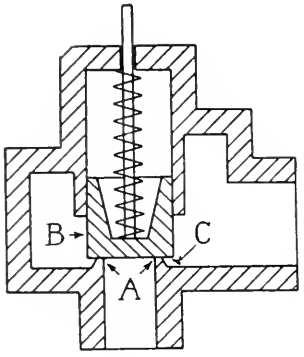
When an inspector next visited the plant they told him of the occurrence and he undertook to find the explanation. The boiler was one of several used to heat a large store building and the safety valves on all boilers were piped to a common line that ran a long distance before opening to the atmosphere. From the unusual length and layout of this line the inspector reasoned that friction would build up an appreciable amount of back pressure while a safety valve was popping, and it occurred to him that there might be something about the safety valve on the boiler in question that caused it to open when pressure was applied to it from the discharge side.

On examining the valve the inspector found that it was of the type shown *diagrammatically* in the sketch. Plunger "B" had no exposed area on which back pressure would act downward to help the spring hold the valve closed. However, it extended a considerable distance beyond the seat "A" so that there was an area "C" on which back pressure could act upward, thus tending to open the valve. For this particular valve the overlapping area was considerably larger than the area exposed to boiler pressure, so a back pressure even less than the rated popping pressure of the valve was sufficient to lift the plunger.

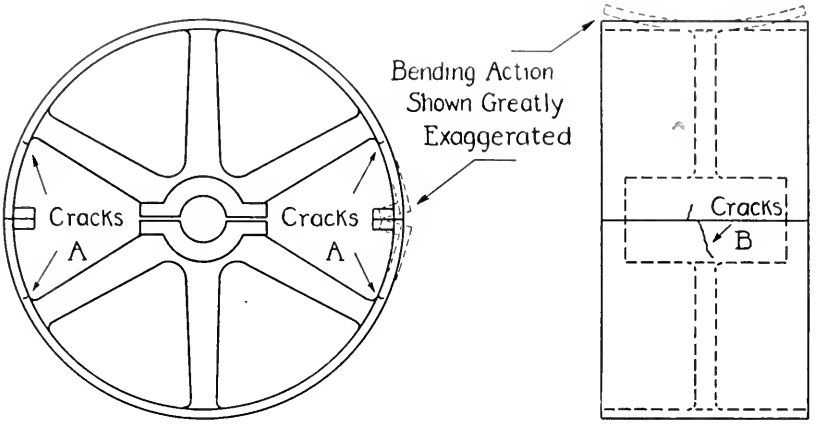
There was no difficulty in finding cracks in every one of them immediately thereafter as shown here in the sketch.

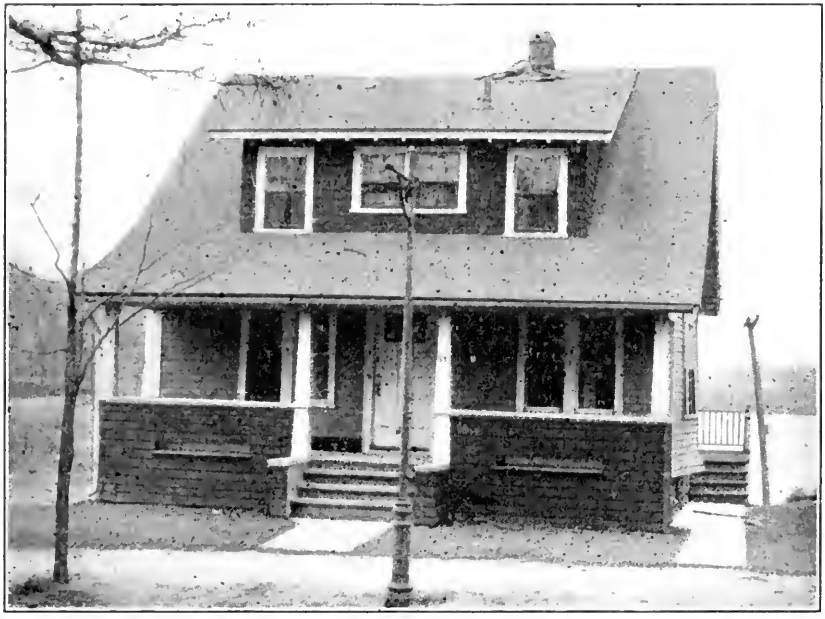
the death of the janitor and the injury of two other men, the janitor was thought to have been working on the boiler when it let go, hurling people from their beds in the apartments and badly wrecking the lower floor of the building. A day after this accident a hot water supply tank exploded in the basement of another apartment house in the same street, tearing a large hole in the floor of the suite directly above it. A woman who was in the apartment suffered from shock. It was reported that there had been repair work done on the tank a few days before the accident.

Another recent explosion occurred on New Year's Day at a residence in Worcester, Mass., where a hot water supply tank shot up through two floors to the roof. Figure 2 shows the hole in the roof where the tank struck, as well as a bulged side wall, but it does not give an adequate idea of the damage to the framework and interior. As in the case previously described, the lower floor of the house was wrecked. Furniture was tumbled about, plaster was shaken down, gas pipes and electric light fixtures were broken, and radiators were wrenched from their fastenings. Because heavy floor beams were broken and the whole framework was seriously impaired, the owner was of the opinion that the house would have to be virtually rebuilt.

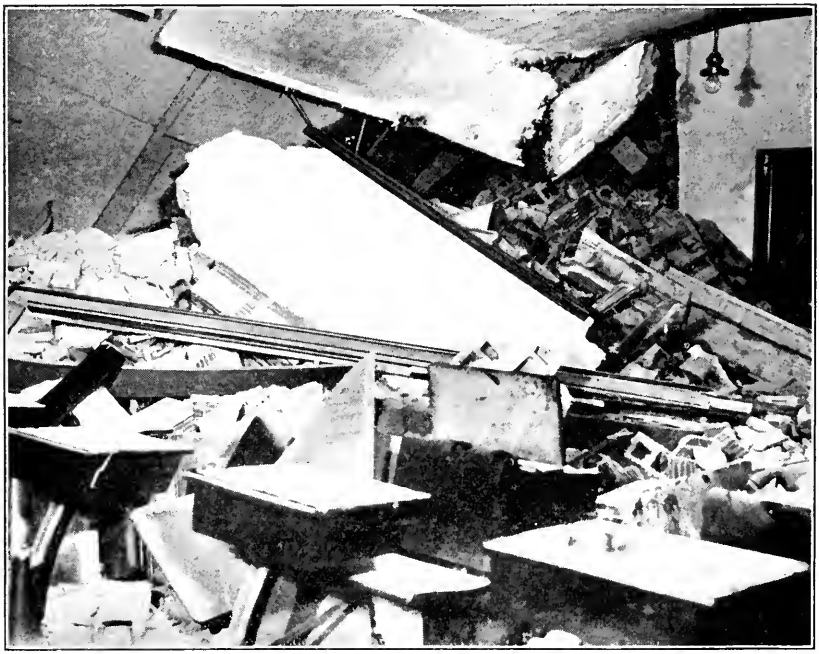
Figure 3

as an exploding hot water tank wrecked the interior of an expensive home. The concussion was so severe that the occupants of a neighboring house were thrown from their beds. In the house in which the explosion occurred walls were cracked, floors were bulged, and the windows as well as doors were torn from their fastenings. Property damage was estimated at $7,500.

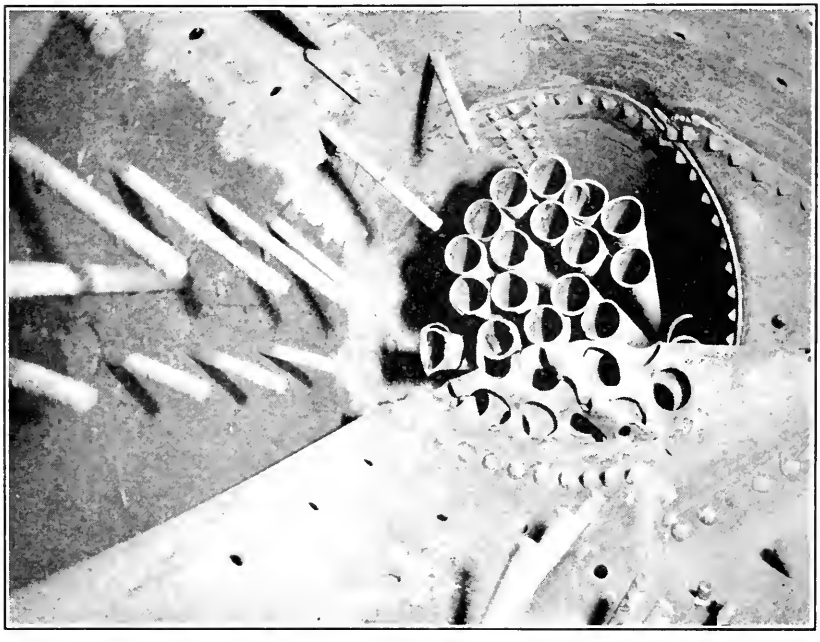
Figure 1

A SAFETY valve in which the spring had been screwed down so far that the coils were tightly compressed led recently to a boiler explosion that caused considerable damage at a laundry in a mid-western city. It is supposed that someone screwed the valve down in order to apply a hydrostatic test to the boiler, and then forgot to

reset the valve before again placing the vessel in service.

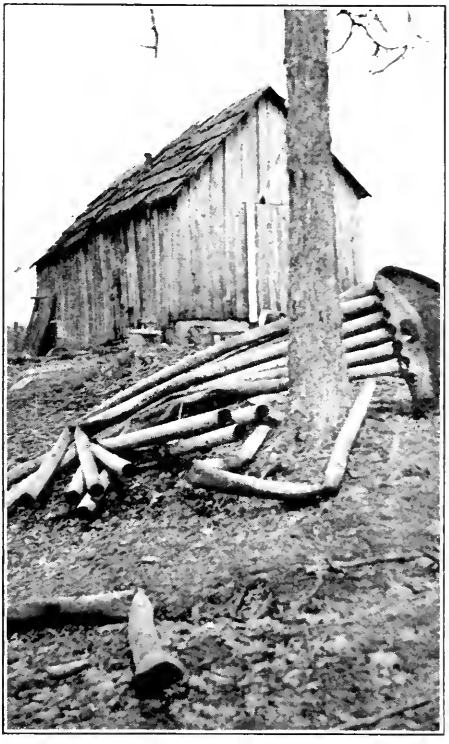
Figure 1

THE most dangerous defect to which old boilers with longitudinal lap seams are subject—grooving and cracking of the seam—caused three explosions within a few weeks of each other early this year. Five men lost their lives and three were injured. To the best of our knowledge, no boiler insurance was carried in any of these cases.

At one plant, a sawmill in a Southern state, a horizontal tubular boiler 36 inches in diameter and 12 feet long failed at the longitudinal seam of the front course on the morning of March 10. This sheet tore away from the front head and second course, crashing into and demolishing a mill building. The two other courses, together with the rear head, sailed like a rocket over another building and came to rest in a copse of wood 900 feet from the starting point. With the tubes still attached to it, the front head was driven against a tree with such terrific force that some of the tubes were bent almost double, as shown in Figure 1. Had the tree not been there, these parts of the boiler would have plunged into the residence of one of the mill workmen. One tube did break away and pass completely through the house, but fortunately it did not strike any of the several women and children who were there.

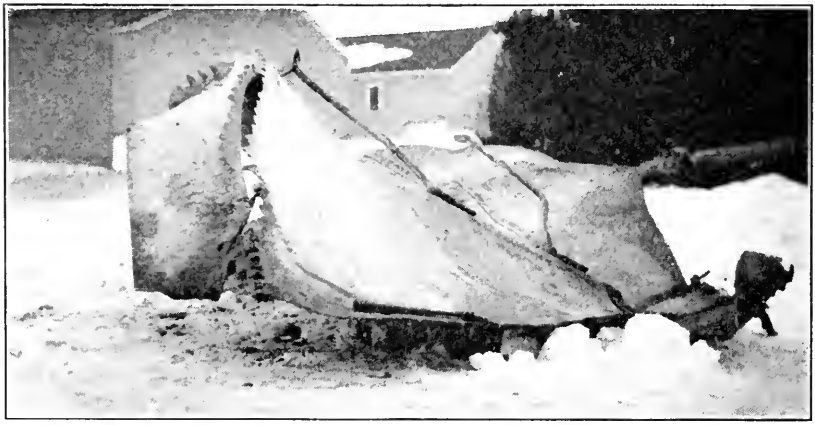
Figure 3

The initial break occurred along the outside surface of the inside sheet forming the double riveted lap-seam of the front course, shown in Figure 3. After this sheet tore loose it sailed over several plant buildings and came down through the roof of a two-story warehouse 400 feet away. The reaction of escaping steam caused the main portion of the boiler to jump backward about 20 feet to strike the main plant

building. The impact was sufficient to move the entire building 15 inches on its concrete piers. Property damage was estimated at $4,000.

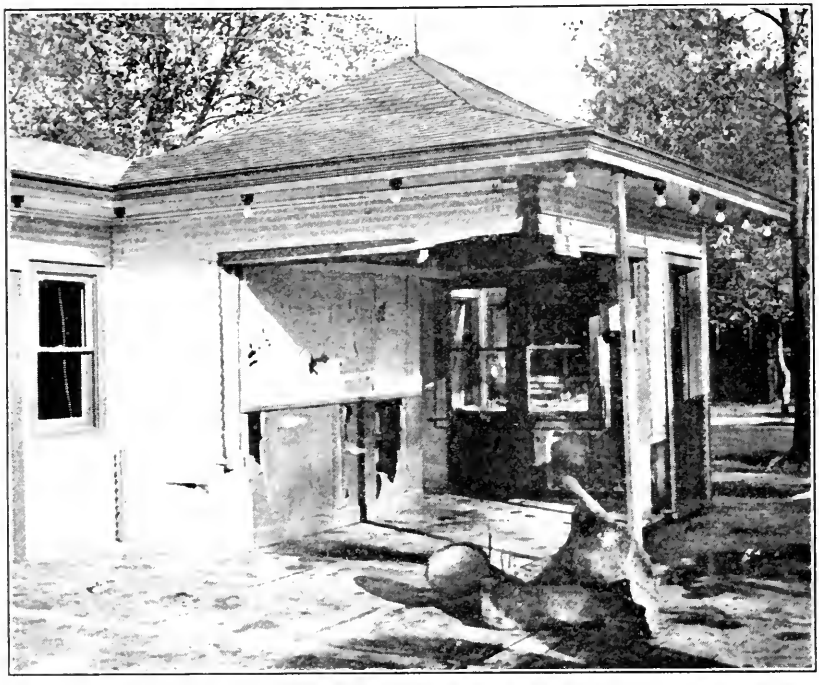
tributes its full share of accidents. In addition to the case just described, there was recently an explosion of a compressed air tank in an Indiana city that tore down two walls of a filling station. The damaged building and tank are shown in the accompanying illustration, which is from a photograph taken after the wreckage had been cleared away. In this case the accident was evidently not caused by any structural weakness of the tank. According to reports, someone screwed down the spring of the safety valve so that it permitted overpressure to develop.

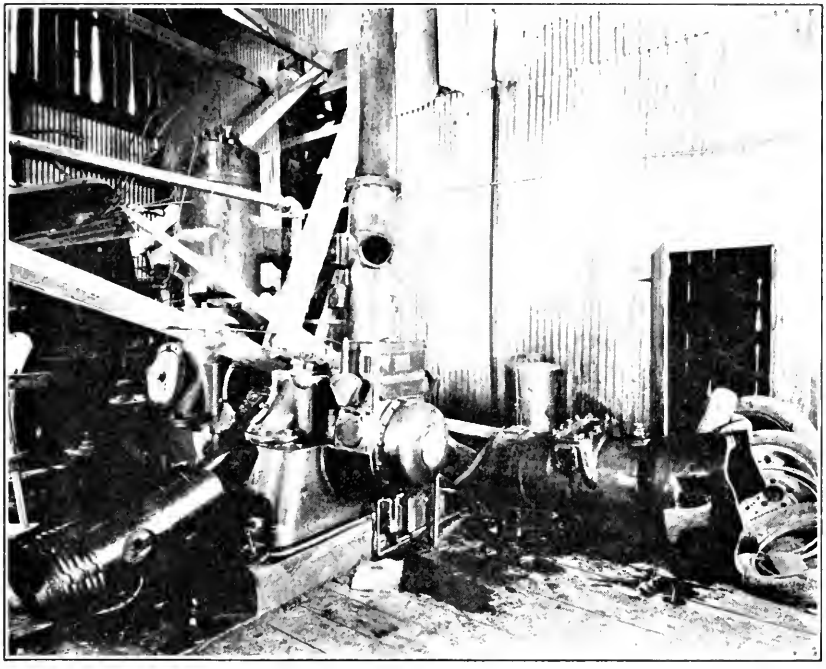
THE operator in a plant in Florida was in the act of starting his Diesel engine on the morning of January 25 when something went wrong with the starting-air mechanism. The resultant explosion tore the cylinder from the crankcase, allowing the piston to fall down and break a large piece out of the engine bed. At the time this

happened, the operator was standing at the starting-air lever, shown in the foreground of the illustration, so it is evident that he was fortunate in escaping serious injury. The plant was not so fortunate, as there was no engine insurance to cover the heavy property loss.

According to accounts of the accident, the mechanism for admitting starting-air in some way became disarranged, so that the cylinder contained air at a pressure of 125 pounds per square inch while the piston was on its upward stroke. As the piston proceeded upward, the air was compressed until it either reached a pressure sufficient to rupture the cylinder or else caused pre-ignition of fuel that may have entered the cylinder during a previous false start. The view of the engine here shown clearly indicates the completeness of the wreck.

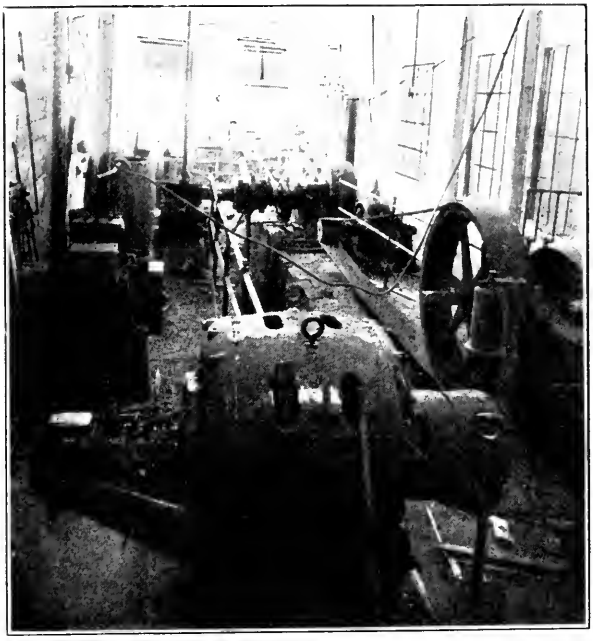
OF SEVERAL engine accidents that have recently come to our attention, two would seem to be of particular interest from the operating engineer's standpoint. The first involved a property loss of about $7,000 from the bursting of a 30 ft. flywheel on a Corliss type engine, and the other killed three men when a cylinder head was knocked out. The wreckage caused by the fly-wheel explosion, which occurred in August at a planing mill, is shown in the illustration. It was reported that spokes were cracked in the governor belt pulley and that when this pulley failed over-speed resulted because one of the safety cams was missing and the other was out of adjustment.

Few details of the other accident are available, but it would seem that the three victims were scalded when trapped in a corner of the engine room by steam escaping from the broken cylinder head, and that the mishap was caused by some breaking or crushing of the connecting rod brasses that allowed the piston to over-travel far enough to strike the cylinder head a shattering blow.

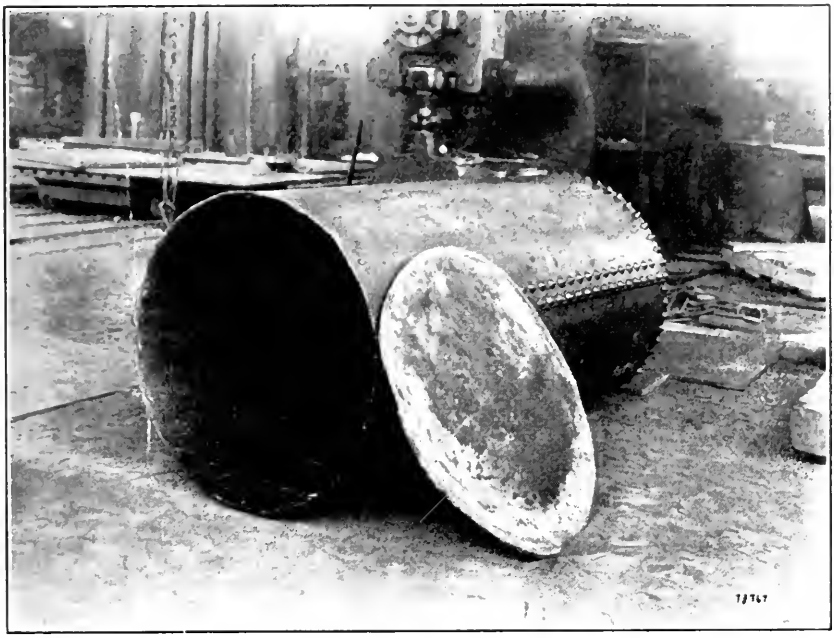
OVERPRESSURE was not a factor in the recent explosion of an air tank in a Milwaukee laundry. The tank was used in conjunction with a motor-driven air compressor and had as protective devices not only a safety valve set to relieve at 80 lbs. but also a motor cut-out adjusted to function automatically at a pressure of 5 lbs. under that limit. As both devices were in good order, it seemed that the explosion must have occurred at a pressure not greater than that for which the vessel was intended to operate.

The tank was 36″ in diameter, 6 ft. long, and was made of ¼″ plate with double riveted lap joints. Its lower head, however, had at some time been replaced with a shallow, skirtless head fastened in place by welding. The explosion occurred when the weld material sheared and permitted the saucer-like disc to tear loose around its entire circumference. Figure 1 shows the flatness of the head and the manner in which failure took place.

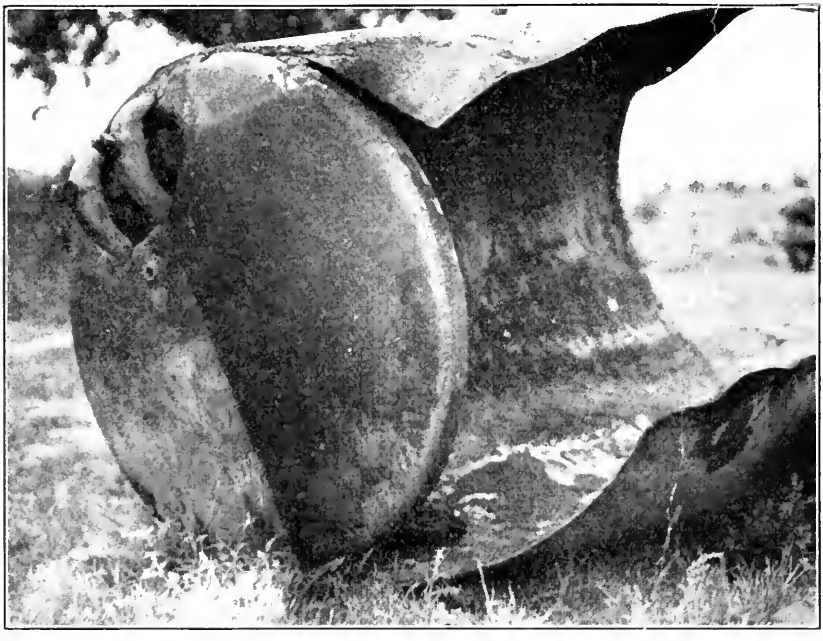
Figure 2

Air was pumped into this tank by a motor-driven compressor. The owner was of the opinion that the safety valve stuck, thus permitting the compressor to build up an excess pressure. However, from an examination of the welded joint that failed, it appeared more probable that defective welding was the cause, for around at least a third of its circumference the head had scarcely been joined to the shell plate.

in the hydro-pneumatic system of water supply. They overlook the fact that, although the tank is partly filled with cold water, the compressed air in the remaining space renders the container as dangerous as any air receiver.

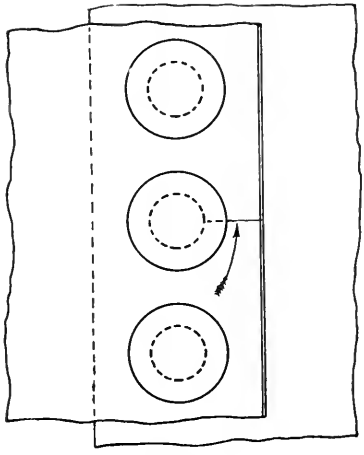
Figure 1

The defect illustrated in Figure 1, which develops between the rivet hole and the caulked edge of the plate, has become universally known as a "fire crack". It first became a source of trouble in railway locomotive operation, a class of service that involves high fire box temperatures and high rates of heat absorption by those surfaces exposed directly to the radiant heat. This condition resulted in temperature differentials, and expansion and contraction stresses that were beyond the endurance limit afforded by the material and workmanship obtainable at the time steel was coming into a common use in boiler construction.

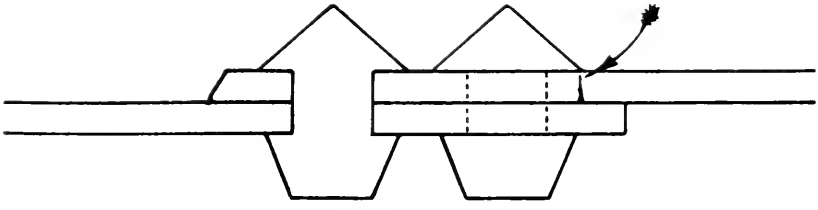
Figure 2

The lap seam crack is found in the overstressed material of one of the sheets where it is hidden by the lap of the other sheet forming the seam. Even at the start the shallow fissure in the surface of the plate may extend the length of the entire course or the length of the entire seam, its depth nearly uniform from end to end. However, the crack grows progressively deeper into the plate along its entire length, so

that when the fracture finally pierces the plate at one point, making its presence known by leakage there, the sheet may be on the verge of being torn asunder by steam pressure from girth seam to girth seam. In fact, such failure has occurred in many cases simultaneously with the first appearance of leakage, so that no advance warning of the disastrous accident was given.

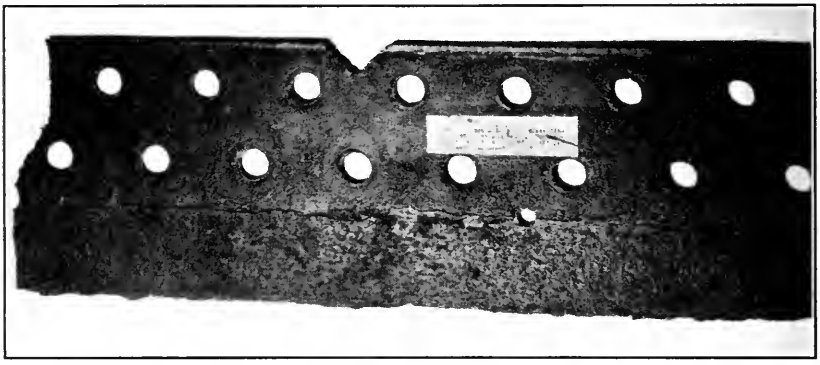
Figure 4

The V notch in the caulking edge of the plate, shown in Figure 4, was made before the plate was removed, to afford our inspector an opportunity to examine the outer surface of the inner sheet of the seam. Similar notches were made in the edge of the inner plate, but the upper row of tubes was located so close to the seam that a thorough examination was impossible. However, there was sufficient indication of cracking

to justify further investigation. The one-half inch diameter hole, visible below the marker pasted on the plate, was drilled into the outer surface of the plate opposite the location where it was thought a crack was developing. The drill did not reach a depth equal to one-quarter the thickness of the plate before the crack was visible across the bottom of the drill hole, as may be judged from the depth of the crack as shown by Figure 3. Owing to the limited range of the telltale holes the exploration slot is preferred and has been used to great advantage since full detail of the method was published in THE LOCOMOTIVE of October 1914.

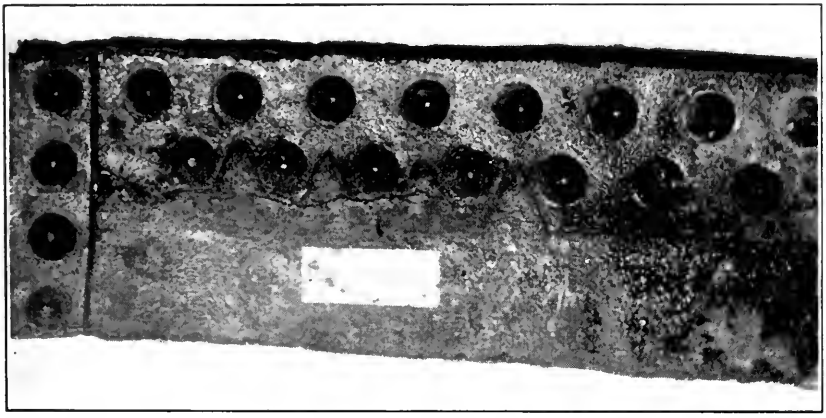
Figure 5

Figure No. 5 is of a section of a lap seam removed from a boiler which was retired from service recently as the result of a discovery of a lap seam crack by one of our inspectors. The boiler was used to furnish steam for prime movers and for process work in a steam laundry where 20 girls were employed in the flat work ironing department adjoining the boiler room. The V notches cut to permit examination of the hidden surface in which the crack was discovered were enlarged after the section of plate was removed from the boiler. The seam shown in the photograph has its normal appearance near the right hand end where the inside lap covers the crack, which, however, can be traced along a line near the edge of the rivet heads where the notches have been cut. The crack did not extend into any of the rivet holes.

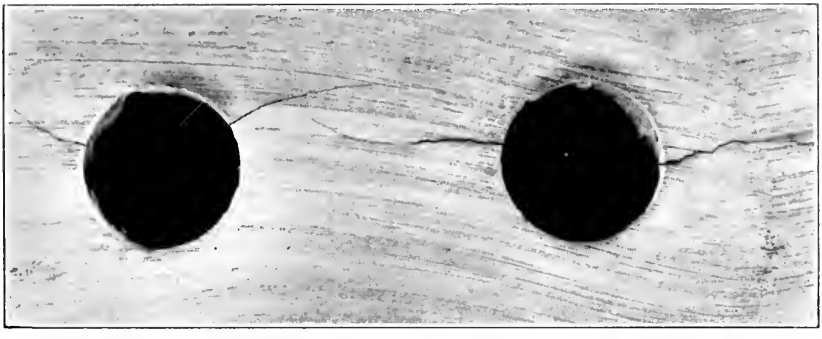
A comparison of the details of Figure 4 with those of Figure 6

will enable the layman without the aid of special optical instruments to distinguish one of the principal differences in the general characteristics of the lap seam crack and the defect resulting from the use of feed water of high alkalinity. The lap seam crack, as has been explained, starts in the surface of the plate, and its depth increases more or less uniformly throughout the length of the course until the plate is pierced, possibly the entire distance from girth seam to girth seam. The fracture may pass through a rivet hole but more frequently is near the line of the edge of the rivet heads. On the other hand, caustic embrit-

tlement defects, whether found in the lap seam or butt strap seam of a steam boiler, reach out in several directions from each of several rivet holes. As in the case of the lap seam crack, there is no serious weakening of the vessel at the start, but the long-continued and progressive deterioration of the cement binding together the microscopic steel crystals may, over a period of time, extend the weakened condition so far into the plate that steam pressure can then cause a sudden and violent explosion.

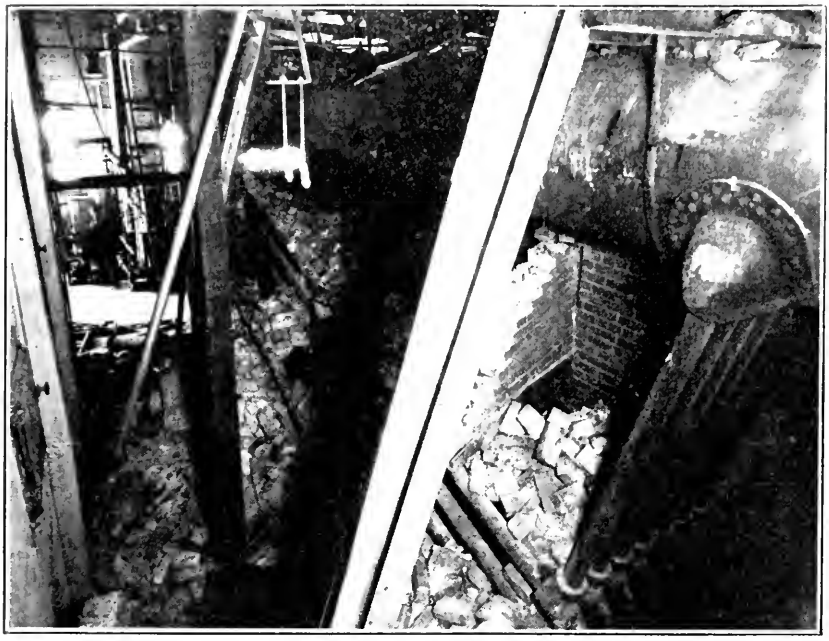
The burner was of rectangular shape, 6″ deep and 70″ wide. Ignition was provided by two gas pilots, one placed at each end of the burner in such a way that no part of the flame was directly in front of the nozzle opening. From the fact that delayed ignition had been a com-

mon occurrence with this arrangement, it was easy to believe that on the occasion just described a great deal of fuel blew past the pilot lights and some of it reached the upper part of the setting before it was touched off. The brickwork covering the overhead circulators between the center and rear drums was completely blown out, as was the brickwork covering the tubes running from the front drum to the square header at the top front of the setting. One sidewall was knocked down.

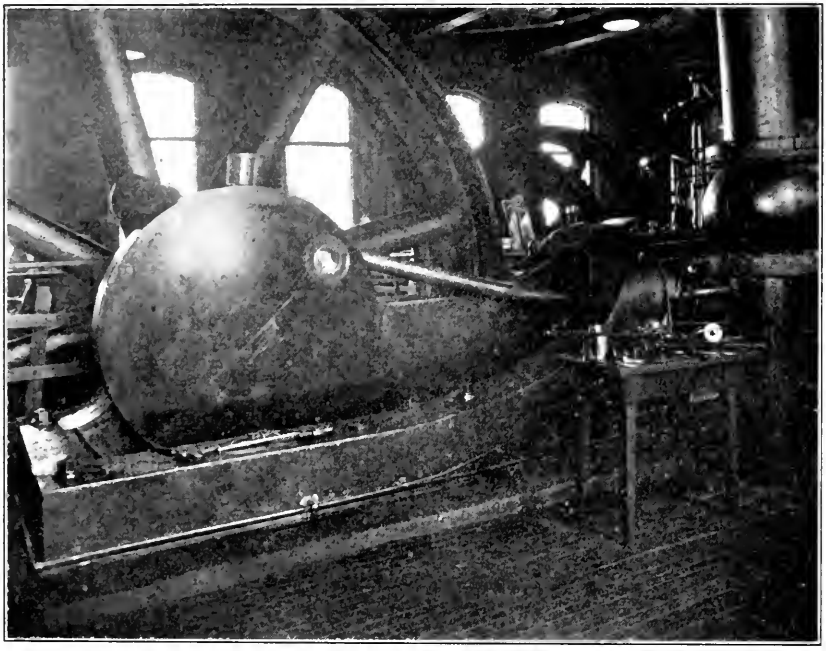
Figure 1

PROGRESSIVE cracking of the crank pin at a point inside the disc recently caused an expensive accident to a tandem-compound Corliss engine in a Mississippi cotton mill. The break permitted the reciprocating parts to strike and drive out the rear heads of both low and high pressure cylinders, as well as to break crosshead slippers and

accident occurred. As is apparent in Figure 1, the pin broke off below the surface of the disc where the crack could not have been seen even with the crank removed. The darker part of the fracture shows the extent to which the crack had gradually worked into the pin. The bright part is the area of sound metal that failed at the time of the accident.

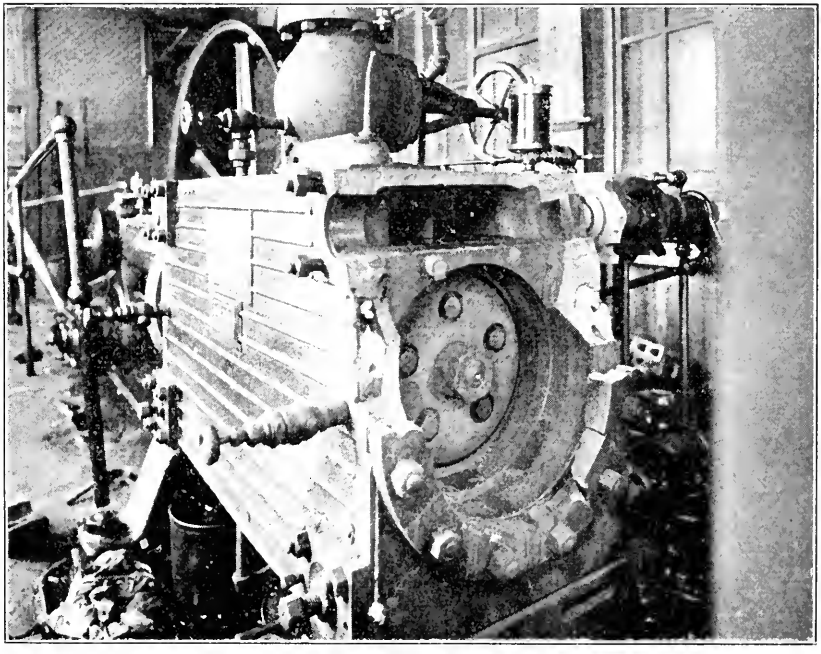
In Figure 2 is shown the head end of a Corliss type engine that was

wrecked in October at a mill in Gloversville, New York, as the result of the breaking of the connecting rod strap. Cast adrift by the failure of the strap, the heavy reciprocating parts rammed the piston against the cylinder head, knocking off the end of the cylinder. The shock of the impact broke the crosshead shoes and bent the connecting rod.

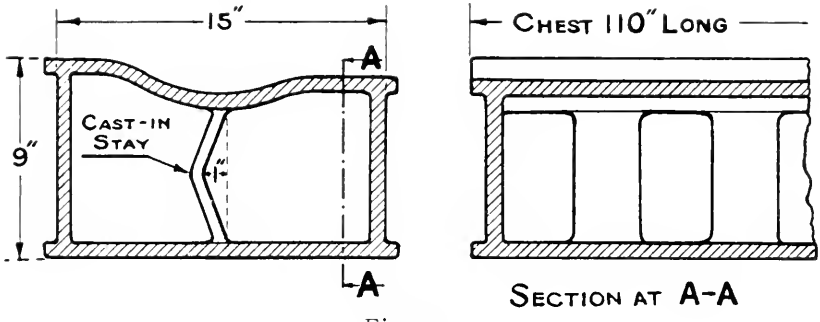
Figure 1

CONGRATULATIONS were in order among a group of eight young women employees of a Texas laundry on August 3rd. They had been away from their work table but a few minutes during the noon recess when it was demolished by the explosion of a cast iron steam chest on a flat work ironer. The force of the blast was such that the top of the chest and a 1,500 lb. roll were hurled to the ceiling before landing at the spot where the women had been working. The lower part of the chest drove downward to sever all manifold piping.

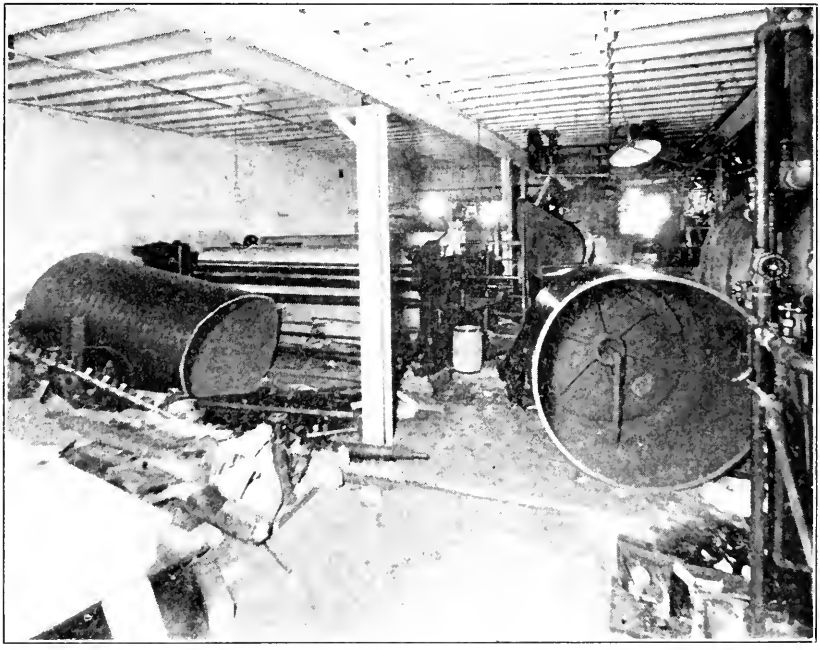
Figure 2

At a laundry in Detroit, the mangle shown in figure 2 was being warmed up after a shut down for the Thanksgiving holidays when the 4′ x 10′ drying cylinder exploded and caused property damage estimated at $3,000.00. This accident was thought to have been the result of stresses set up in the cast iron by unequal expansion, for the fact that the damage was not extensive, except to the machine, indicated that the cause was not excessive pressure.

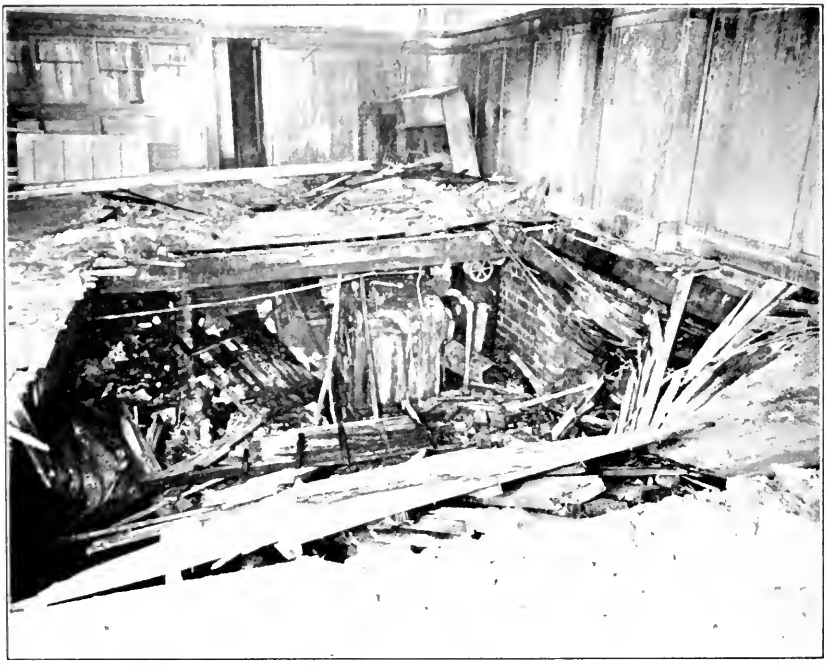
THE account we have received of the heating boiler explosion pictured below, indicates that the safety valve was either inoperative or else it was not large enough to relieve pressure that increased rapidly when an attendant closed the stop valves in both the steam and return lines. This accident occurred on December 2 at the

showroom of a large automobile agency, and although several automobiles on the showroom floor were badly damaged—two of them falling into the hole shown in the picture—only one person was injured. That happened to be a passerby who stopped to look at the display of cars and was cut by pieces blown from the plate glass window.

The boiler was hurled about twelve feet from its setting and driven through a stout brick fire wall. The damage was estimated at $10,000.00. As far as is known, there was no boiler insurance in effect.

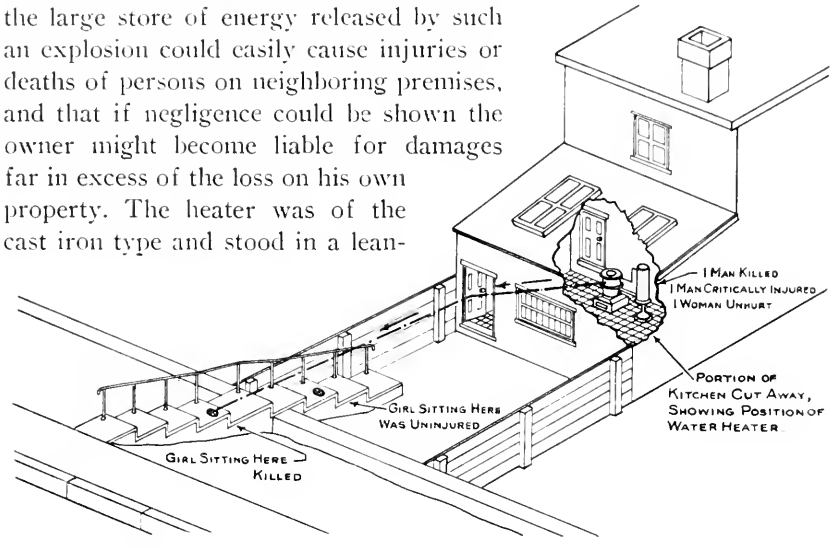
1 Man Killed
1 Man Critically Injured
1 Woman Unhurt
Portion of Kitchen Cut Away, Showing Position of Water Heater
Girl Sitting Here Was Uninjured
Girl Sitting Here Killed

Municipal authorities attributed the accident to stoppage of pipes by corrosion and sediment. In the absence of a safety valve this blocking of the circulation could have permitted overpressure that could not be relieved by the backing out of hot water into the city mains.

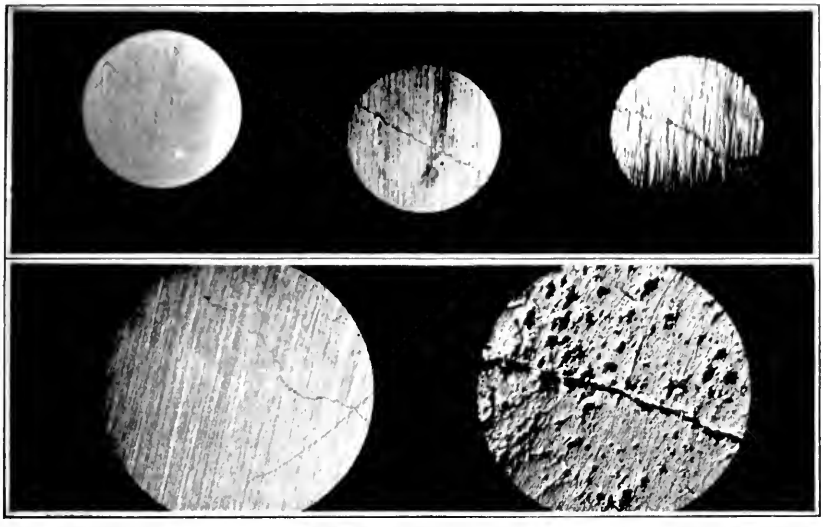
How the microscopic caustic embrittlement cracks look through the eye of the camera connected to the Hartford magniscope. It is important to remember that these tiny hair cracks, while they develop slowly at first, may weaken the plate to a point where the boiler explodes. The upper three photographs were made with 20 magnifications and the lower two with 40 magnifications.

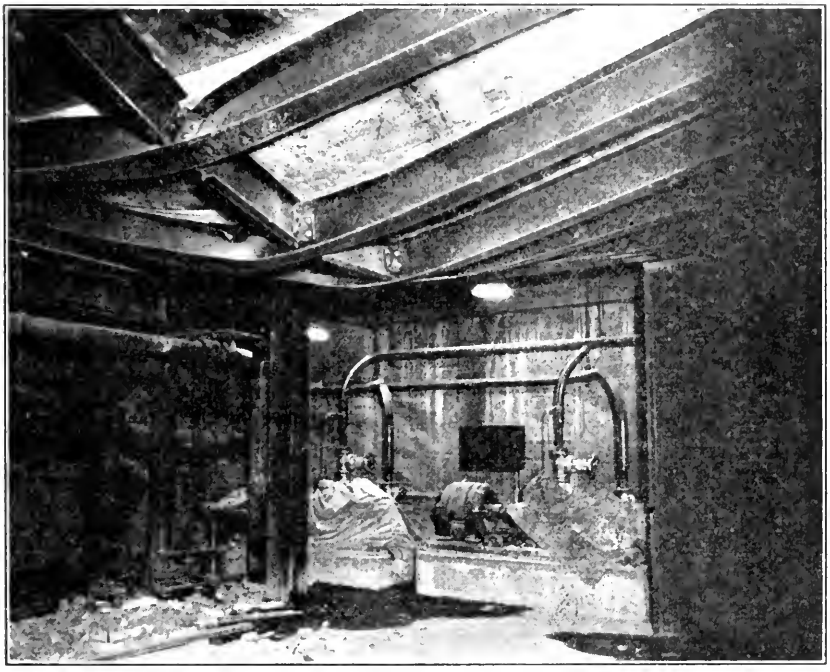
ONE man was killed and three others were injured by a terrific explosion of natural gas in the furnace of a boiler at the municipal plant of Colorado Springs on the morning of January 31. Occurring with such force as to destroy the brickwork of the boiler setting and bend the heavy 12-inch I-beam supports as though

they were putty, the blast endangered the lives of between 20 and 25 workmen engaged in putting the finishing touches on the new plant.

The boiler, a large one of the cross-drum, straight-tube type, had been put in place, and men were about to boil it out to prepare it for an acceptance test when a torch thrust into the combustion chamber ignited a charge of gas that had accumulated there. The resultant explosion not only rocked the boiler almost loose from its support but burst out the metal framework of windows in the building and did considerable damage to the brick walls of the setting and the power house.

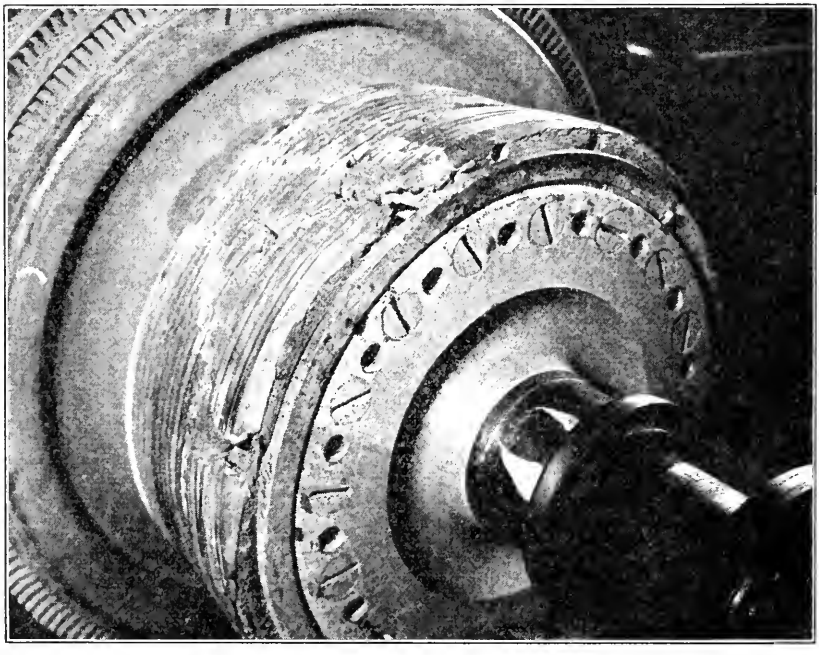
An accident to a 3750 kva turbine at Charleston, West Virginia, the basic cause of which was undetermined, manifested itself in a breaking of the rotating dummy ring (see illustration), rubbing of

and injury to blades, and a distortion of the spindle. Because of reports of smoke between the oil tank and the turbine casing, prior to the failure, and indications at several places of excessive heat, the theory was advanced that the burning of confined oil in the asbestos lagging caused sufficient heat to warp the casing, thus causing the stationary and the movable dummy ring to rub, leading to a chain of events which brought about serious damage. Repair costs in connection with this accident exceeded $15,000. Restoration of the turbine's usefulness involved repairs to the spindle, replacement of blading, and replacement of the spindle and cylinder dummy rings, gland runners, gland cases, primary nozzle block, governor stand and some other parts.

Repairs to the bearing bracket were required, with a general inspection and repair of the entire mechanism.
